4th World Landslide Forum

Landslide monitoring at the Cala Rossa sea cliff (Favignana Island, Sicily)

Luca Falconi¹, Roberto Iannucci², Salvatore Martino²,
Antonella Paciello¹, Augusto Screpanti¹, Vladimiro Verrubbi¹

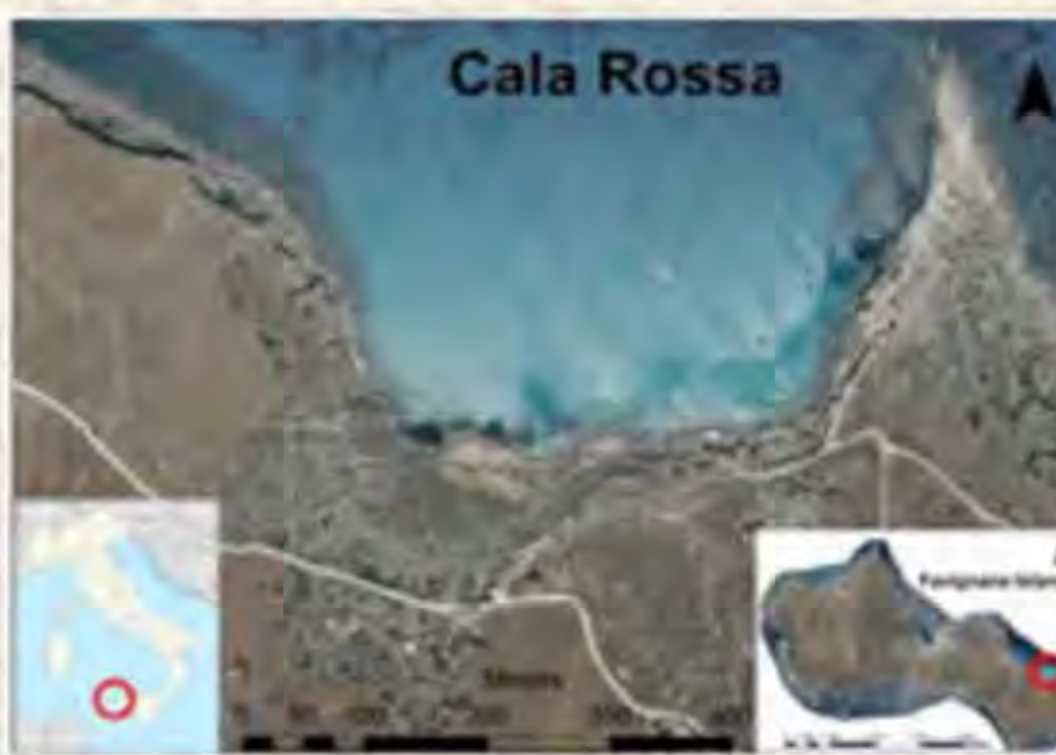
STUDY AREA

Favignana, the largest of the Egadi Islands, is surrounded by 33 km of indented and mainly rocky coastline, marked by natural and anthropic cavities. The study is focused on the bay named "Cala Rossa", located in the eastern side of the island, where the Pleistocene biocalcarene forms some cliffs with height ranging from few meters up to over 30 meters. In the west side of Cala Rossa, the stiff rock slab lies on the ductile clays belonging to the Pliocene formation. The contact between the two formations can be recognised here above the sea level, while in the east side of the bay the surface is presumably below sea level. Such a juxtaposition leads to a lateral spreading phenomenon that

induces the fracturing of the stiff rock slab and the detachment of single rock blocks by typical rock landslide mechanisms (i.e. planar sliding, wedge sliding, toppling and falling). The resulting landslide process should be defined as a complex-type. The calcarenite shows relatively high values of porosity related to the low diagenetic process, the low cementation (spathic calcite with meniscus structures) and to the textural characters (equidimensional, well sorted, loosely packed, low fine grained matrix). The value of the compressive strength offered in literature, and confirmed through some field measurements with a Schmidt hammer, indicates a weakly cemented carbonate rock.
